JONES RIVER BASIN  
KINGSTON, MASSACHUSETTS

FOUNDRY POND DAM  
MA 00394

PHASE I INSPECTION REPORT  
NATIONAL DAM INSPECTION PROGRAM

FEBRUARY 1980

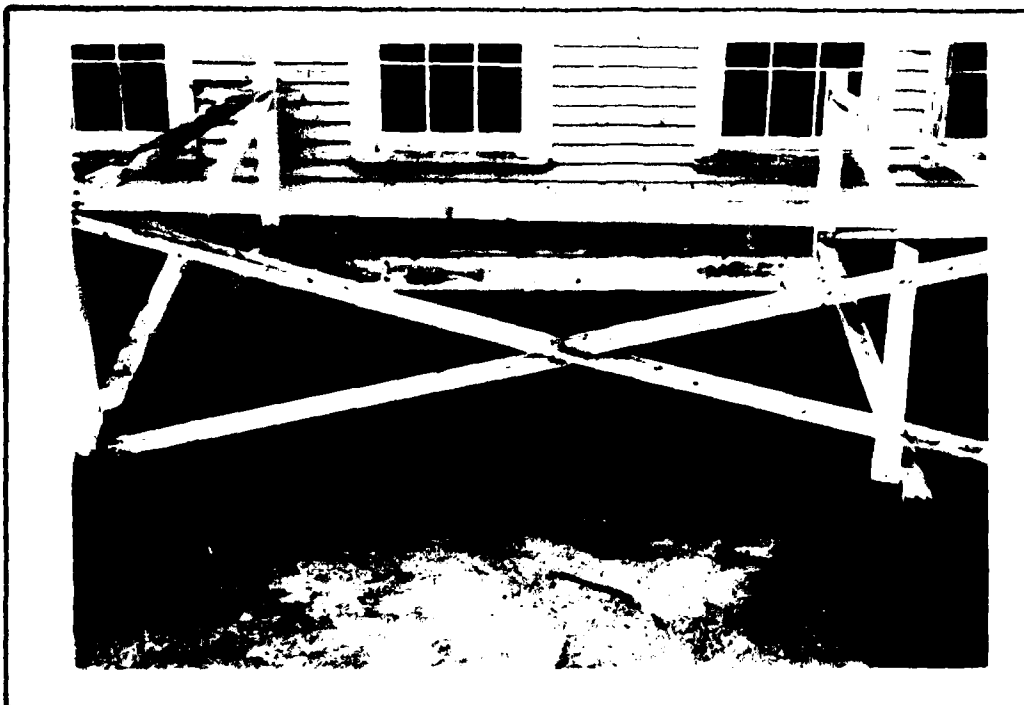
8. SPILLWAY DISCHARGE CHANNEL EMERGING FROM BENEATH INDUSTRIAL BUILDING  
ABOUT 170 FEET DOWNSTREAM FROM THE SPILLWAY. (10/24/79)

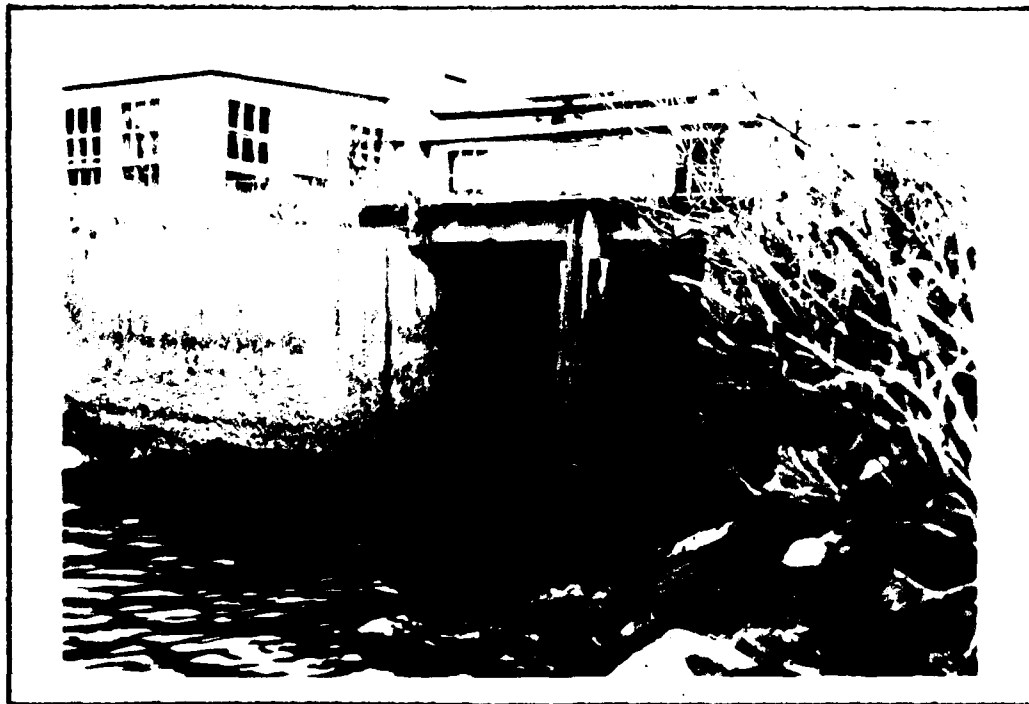
2. UPSTREAM END OF THE SPILLWAY SYSTEM WITH THE INDUSTRIAL  
FACILITIES IN THE BACKGROUND. (10/24/79)
